## **OFFICIALS NEWSLETTER ISSUE 4: SCRUTINEERS**

### **Fuel cell inspection**

## **New Vehicle Damage Report**

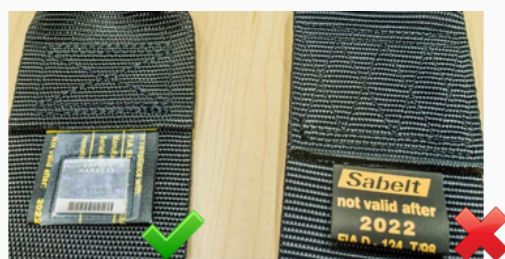
2.

- Stitching pattern: Where the belt material loops around to attach to snap-locks and tabs that lock into the buckle.
- Just by eye, you can see that the genuine belt (left) uses a much denser stitching pattern. The genuine harness also includes a FIA hologram certification along with serial numbers for the product.

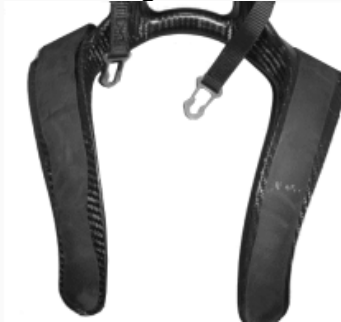
2. Whether there are any signs of wear or friction on the FHR surface in contact with the shoulder belts, as shown in Figure 2.

*Figure 2 – Signs of wear on the rubber surface*

- If any of the abovementioned points are identified, the FHR device is to be sent to the manufacturer or their agent so that tests can be performed in order to check the structural integrity of the device.

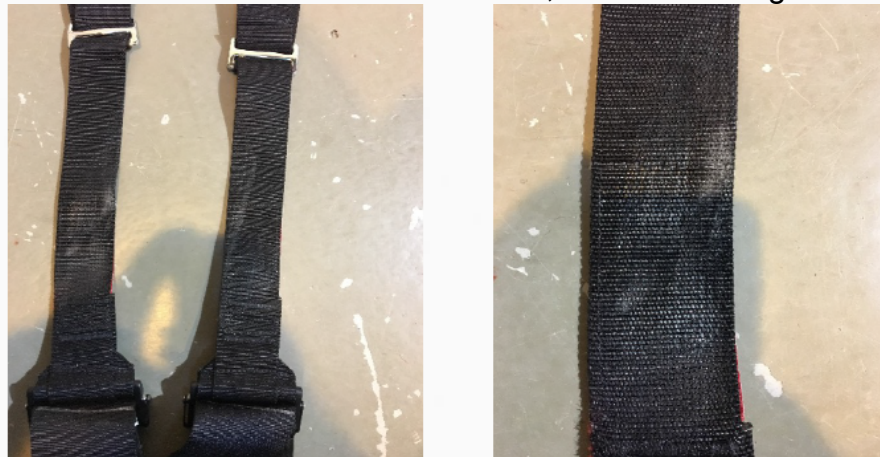
3. Whether the shoulder belt has been stretched, as shown in Figure

- The safety harness shall be replaced, as webbing that has been stretched will not perform as desired during a second accident.
- FIA Standards 8858-2002 and 8858-2010 have constructed in such a way that the first part of the device to be damaged in the event of an accident is the FHR tether.

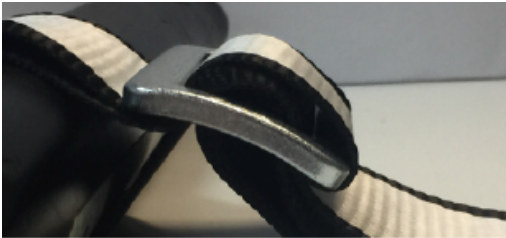
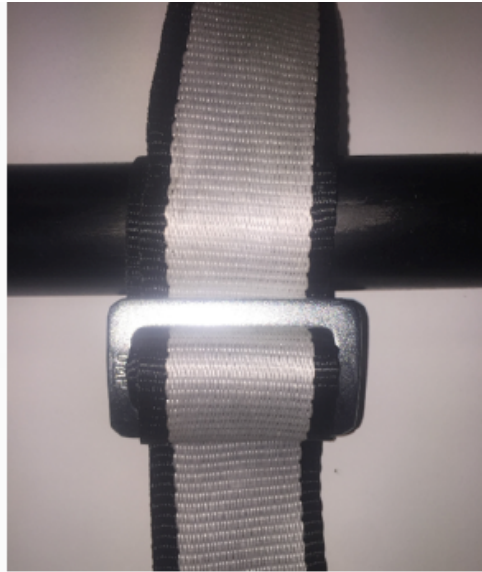
- Sometimes the belt is not looped back, which can result in slippages that unintentionally increase the length of the belt.
- Another factor is to ensure that the buckle is as close possible to the roll bar if this method is used (example pictures below). This will reduce the belt movement, which could possibly compromise other aspects of the belt system if used with FHR.
